# Limited Asbestos Survey and Lead-Based Paint Screening

REPORT DATE: January 09, 2025

517 Channel Street,  
Stockton, California 95202

AEI Project No. 502869  
Site Assessment Date: December 19, 2024

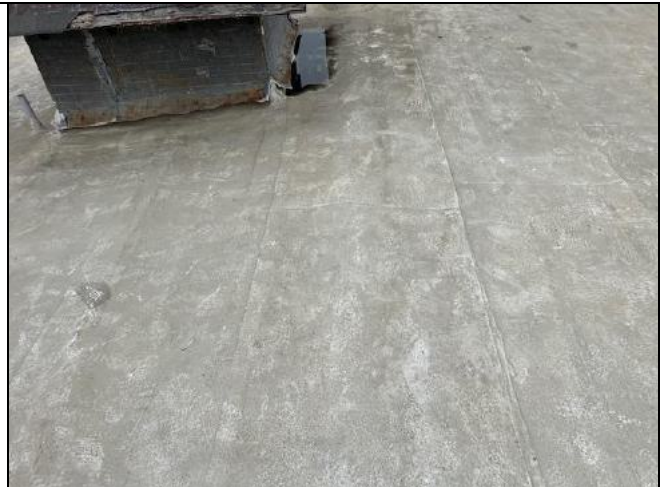
View of **Rolled Roofing with White Coating (ACM)** Located  
on the Roof.  
(Photograph 2)

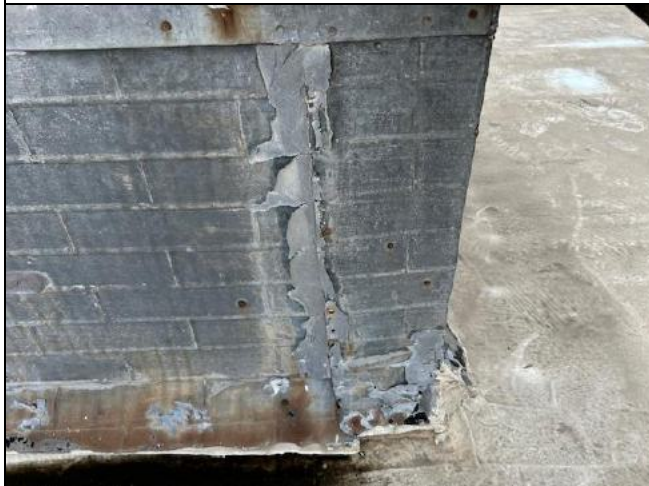
View of **Gray Roof Mastic (ACM)** Located on the Roof Vent.  
(Photograph 3)

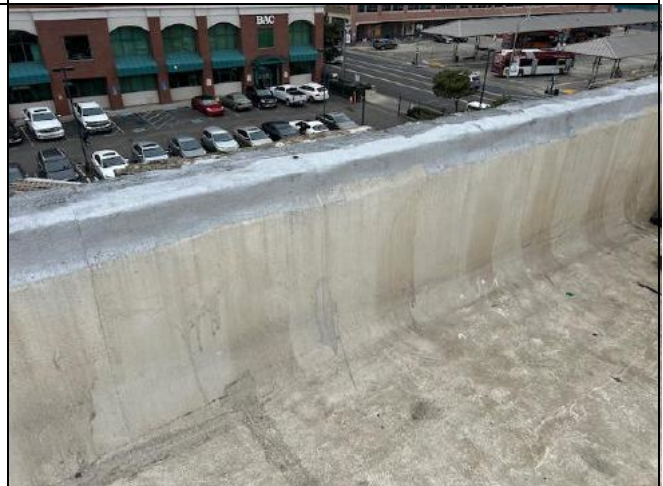
View of Silver Roof Coating – **Black Roofing Material (ACM)**  
Located on the Roof Parapet.  
(Photograph 4)

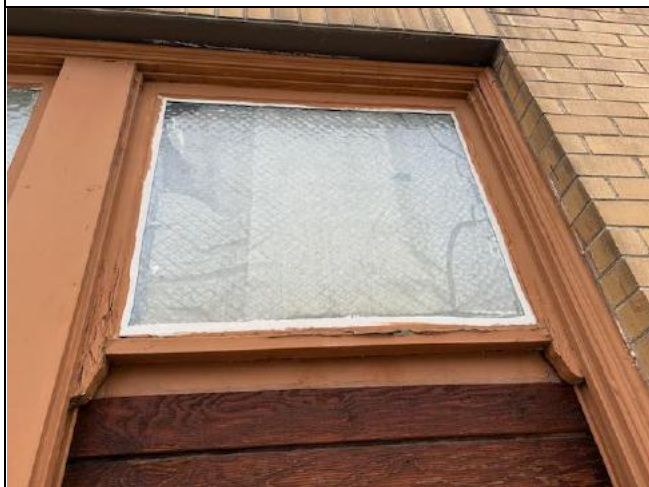
View of Window Glazing – **Brown/Gray Window Glazing (ACM)** Located on the South Exterior Roof.  
(Photograph 5)

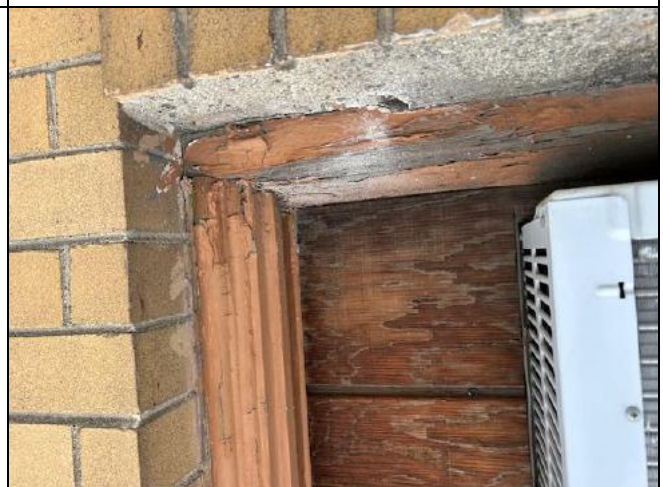
The painted surfaces were observed in fair to intact condition and may pose a potential health and safety concern to occupants of the subject property in their current state.

Brown **Exterior Window Trim (LBP).**  
(Photograph 6)
